**DEPARTMENT OF ENVIRONMENTAL QUALITY
WEST CENTRAL REGIONAL OFFICE**

SUBJECT: New River PCB Source Identification
Sample Collections and Analytical Results

DATE: July 16, 2004; Celanese Figures revised 3/14/2010

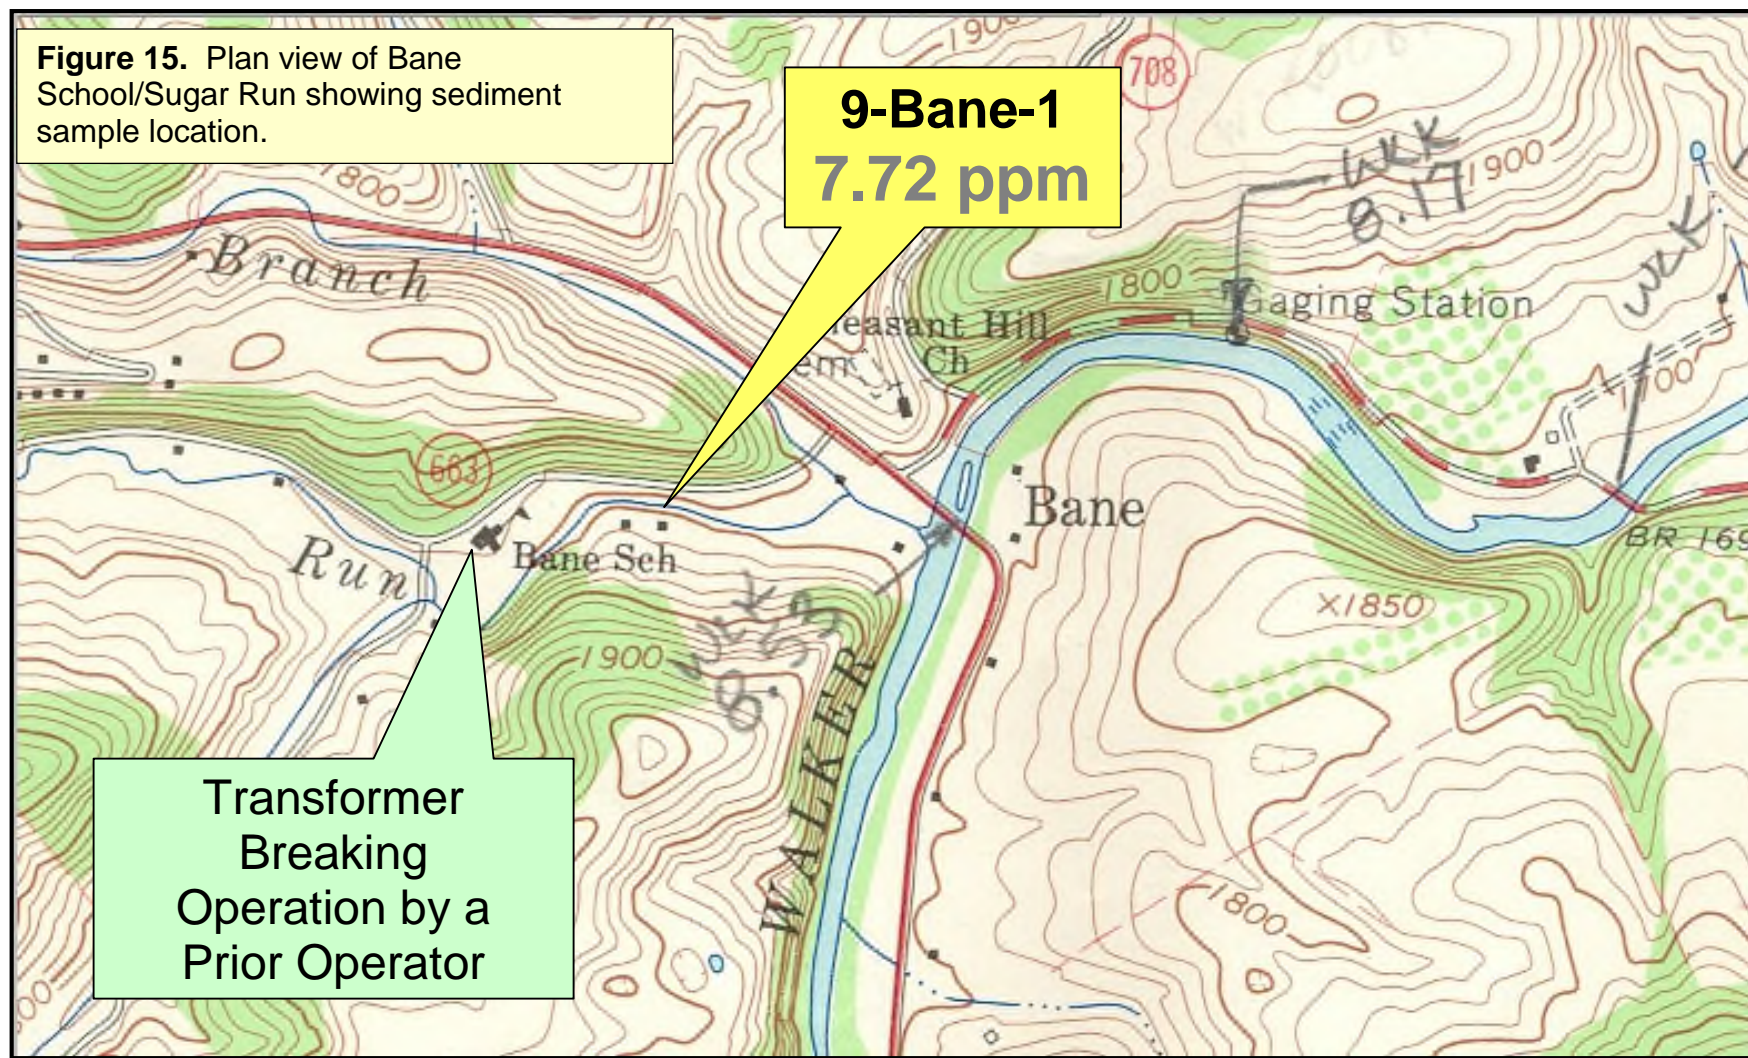
Figure 15. Plan view of Bane School/Sugar Run showing sediment sample location.

The sediment sample location and associated PCB concentration (in ppm) is depicted in **Attachment B**, Figure 15. The sediment sample location description and associated PCB concentration is also presented below in Table 15. Sediment data from Sugar Run below Bane School appears to be very high for an in-stream sediment concentration. Repeat sampling of stream sediment in Sugar Run below Bane School, and on-site sampling of the Bane School site, appears to be warranted.
